National Register of Historic Places  
Registration Form

historic name Williams' Store

street & number 7109 SE Highway 66 [ ] not for publication

city or town Riverton [ ] vicinity

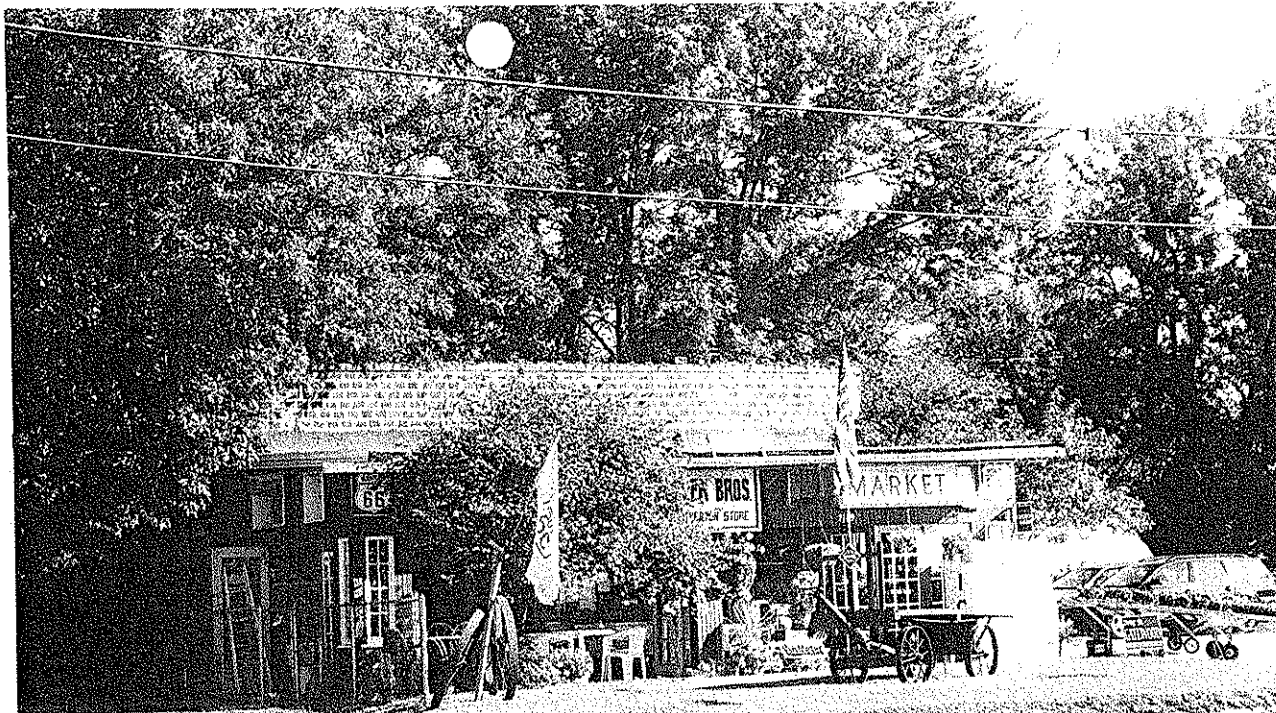
#1

- 1) South elevation, view looking north.
- 2) South and east elevation, view looking northwest.
- 3) East elevation, view looking west.
- 4) West elevation, view looking southeast.
- 5) North and west elevations, view looking southeast.
- 6) South and east elevations, view looking northwest.
- 7) Front (south) porch, view looking northeast.
- 8) Store interior, view looking northwest.
- 9) Store interior, view looking south.
- 10) Built-in cabinet in living quarters, view looking east.
- 11) Greenhouse, view looking northeast.
- 12) Outhouse, view looking northwest.
